OKAGAWA FEDERAL 23A-33-692 (A-A')

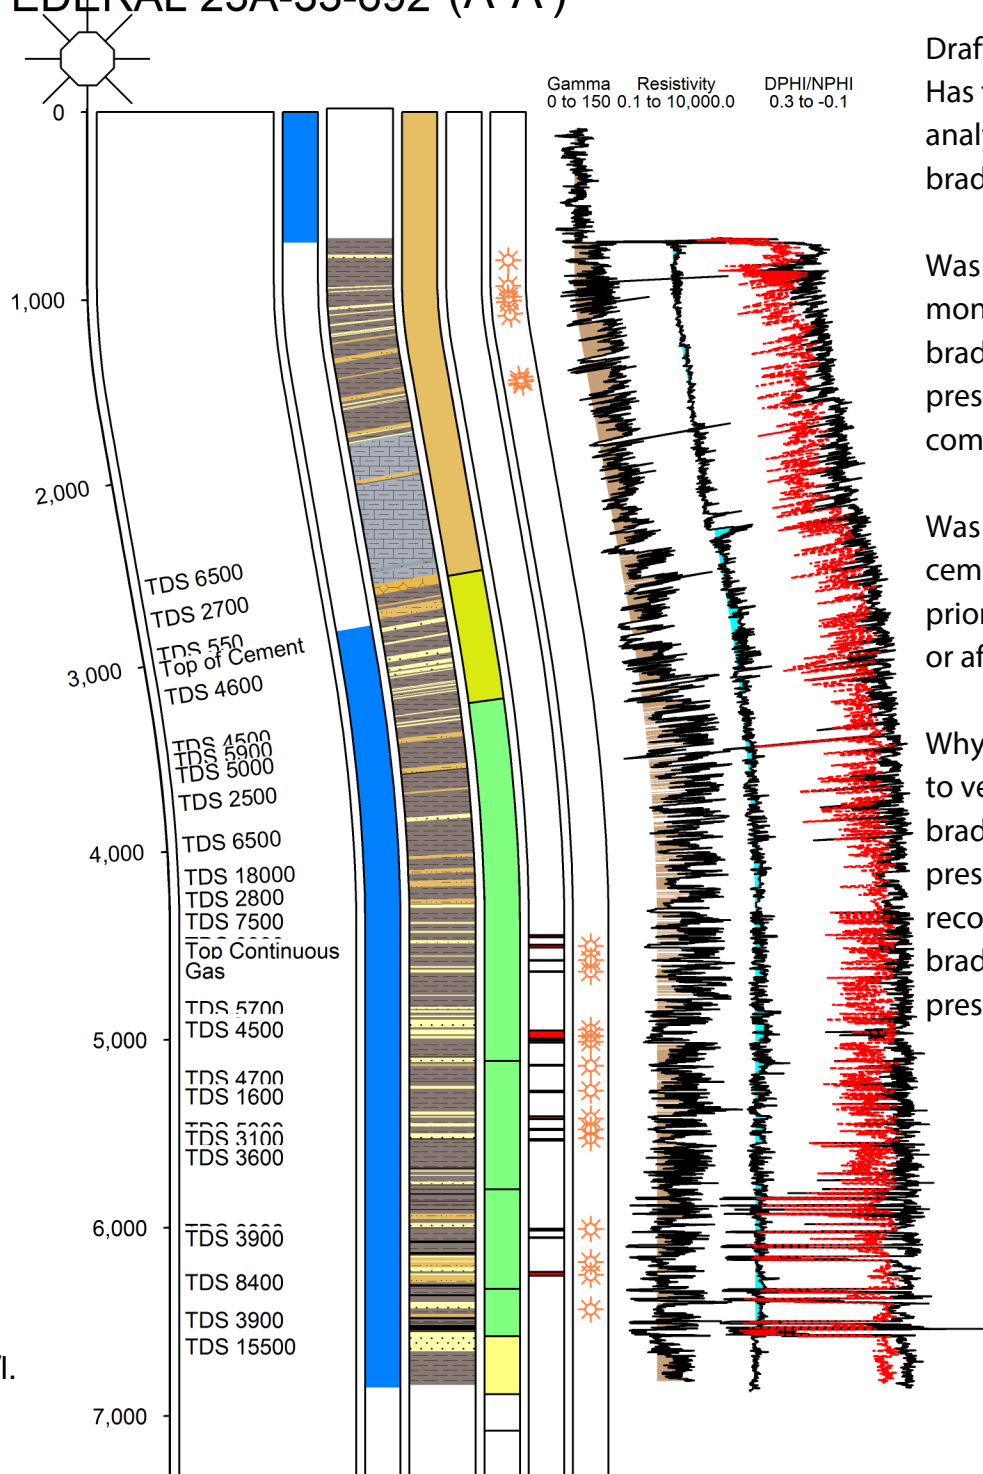
- 1.) Prior to completion, the pressure in the bradenhead annulus was 40 psig.
- 2.) On Request to Complete Sundry Notice, the operator identified poor cement bond from 3000 ft (top of cement) to 4880 ft.
- 3.) There are gas shows in the Williams Fork formation that are being produced and are in contact with the annulus with poor cement bond. There are also gas shows in the Wasatch formation in contact with the open bradenhead annulus.
- 4.) The 2013 and 2014 bradenhead pressure test reports from the operator specified the final bradenhead pressure as 0 psig.
- 5.) The 2015 inspection report specified that the bradenhead valve was open and that the well was venting.
- 6.) The calculated TDS in the lower Wasatch formation ranges from 2700 to 6500 mg/l.
